Deterioration of Stone and Mineral Materials from the Roman Imperial “Villa of the Antonines” at Ancient Lanuvium

Gregory A. Pope, Deborah Chatr Aryamontri, Laying Wu,
and Timothy Renner

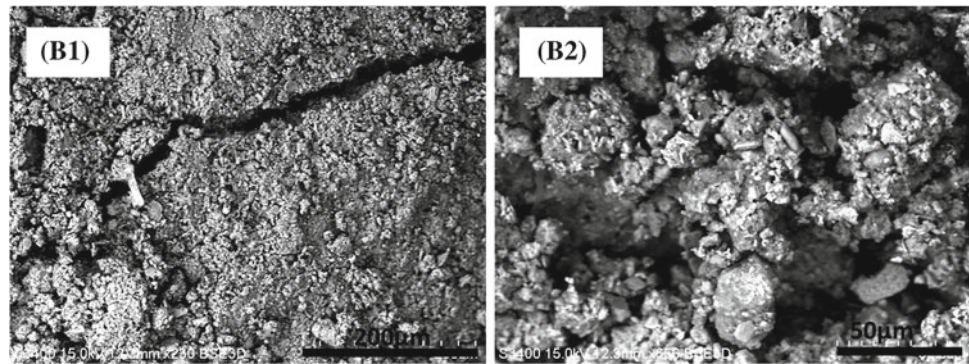
At the macroscopic scale, a cross-sectioned brick fragment exhibited a distinct discolored rim along the perimeter of the fragment surface, approximately 1 mm in width. This rind was a post-burial formation, developing parallel to the fragmented surface, not related to the original surface of the fired brick. Oxidation was probably involved; elucidation of other chemical alteration processes to the clay minerals will await further microanalysis.

One brick fragment was imaged with SEM, BSEM, and qualitative element mapping (EDS) (Fig. 87.2). At magnifications ~ 200 – $2000\times$, the surface appeared granular, with aggregate particles ~ 5 – 20 μm in diameter. Fissures ~ 20 μm wide and up to several 100 μm in length crossed the soft material, probably the result of wetting and drying cycles (Lopez-Arce and Garcia-Guinea 2005). EDS indicated elements expected for clay minerals: Si, Al, Ca, K, Mg, in homogeneous distribution. Iron was also present (visible in element mapping and likely visible as brighter areas in BSE images), contributing to the oxidized surface over ~ 20 % of the fragment surface.

Fig. 87.2 Weathered brick. **B1** showing fracture. **B2** showing granular texture

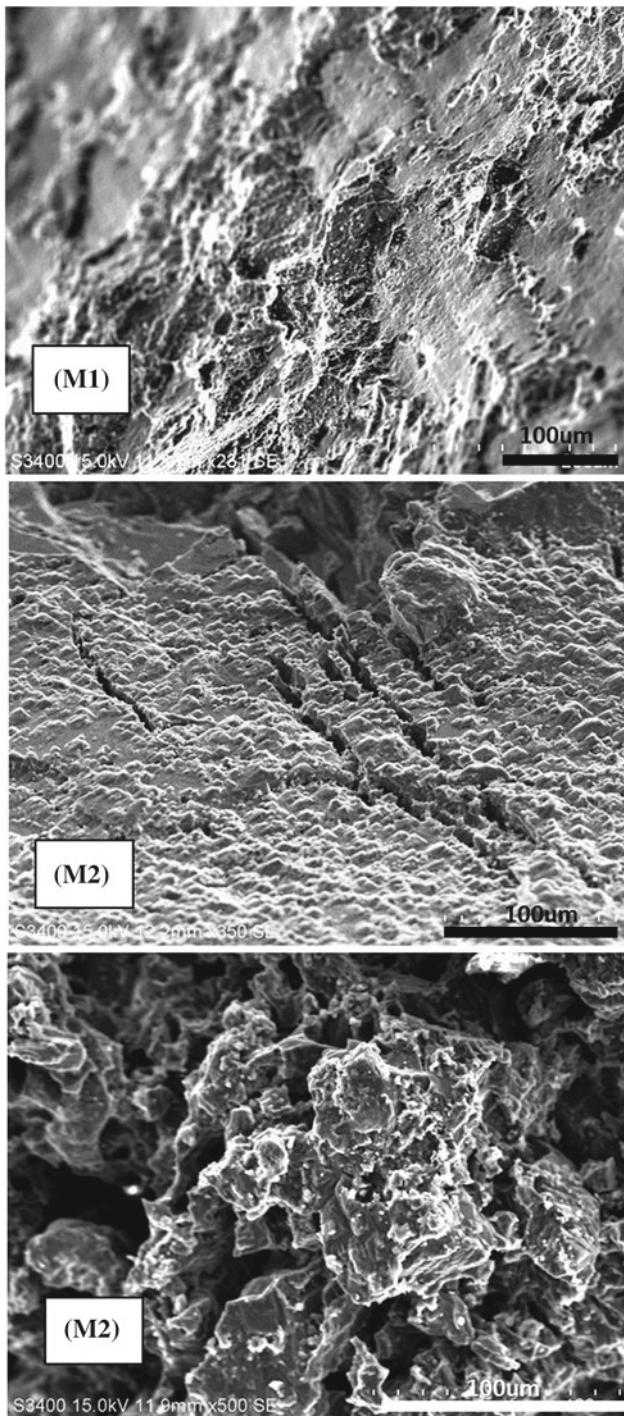
Like the brick, marble fragments at the study site varied in the degree of deterioration, including some that retained polish. None of the “Villa of the Antonines” marble samples recovered from the soil retained any glassy polished surface, though they are presumed to have been polished at one time. The marbles did retain flat faces, often with granular disintegration. For comparison, the modern marble (M1) did have a polished surface evident at the macroscopic scale, while SEM revealed a polished surface covered with shallow roughness interspersed with striated smooth glazing (Fig. 87.3 upper). No cracking or deep intergranular pitting was seen in M1.

The granoblastic M2 sample was composed of elements consistent with calcitic and dolomitic marble, with prominent amounts of both Ca and Mg. M2 exhibited extensive surface weathering features. A relatively smooth area (Fig. 87.3 middle) showed an etched surface of shallow, oriented crystal points (<10 µm in relief) split by several parallel fissures 5–10 µm wide and ~100 µm long. The etching was a product of chemical solution, while the cracking may have been the result of one or more agents: calcite crystal thermal expansion, salt crystal growth, fire, or

physical stress on the stone (Rapp 2002). Elsewhere on the same sample, the surface was deeply pitted, resembling “grikes and clints” karst topography (Fig. 87.3 lower).

Fig. 87.3 Marble samples. *Upper*, modern marble (M1), minimal deterioration. *Middle*, parallel cracking in M2. *Lower*, dissolution pitting in M2. 100 μm scale bar in each image

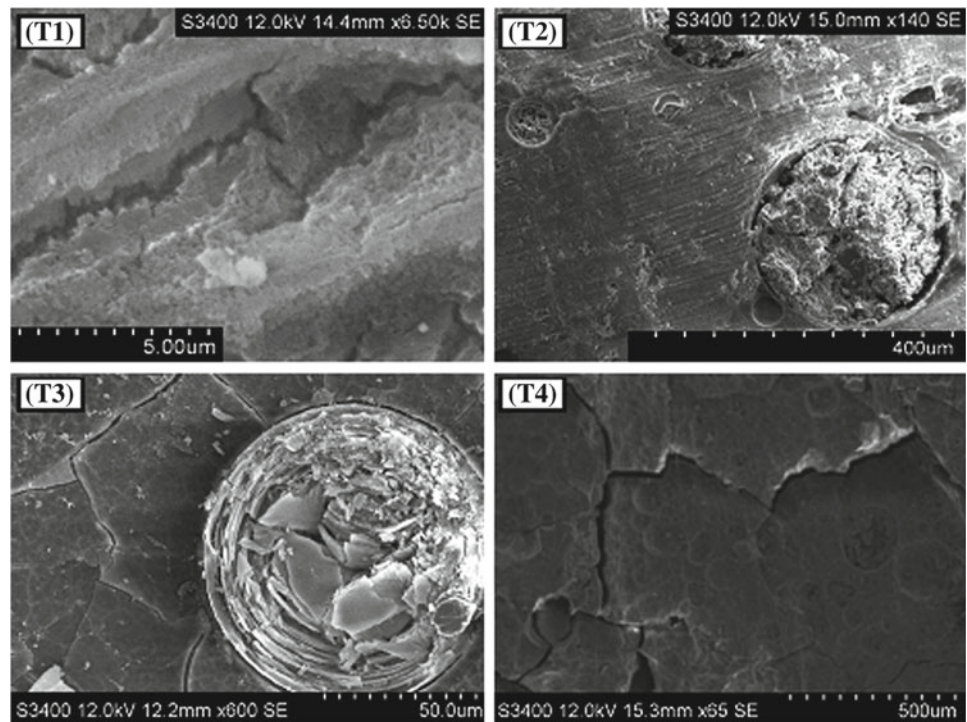
The most common features of the tesserae were shallow circular pits or craters, occasional on some surfaces such as T1 but ubiquitous and extensive on other surfaces, such as T3 and T4 (Fig. 87.4 lower right). The craters ranged in size from 20–80 μm in diameter and in depth $<5 \mu\text{m}$. We interpret these to be weathering features as they were limited to exposed surfaces and appeared to overlay manufacturing features, such as the striae. Cratering is probably related to chemical dissolution, described by Branda et al. (1999). Craters are not to be confused with often larger and deeper circular vesicles, interpreted as being bubbles in the glass, a product of manufacturing (Croveri et al. 2010). Bubbles do play a role in the surface deterioration, however. In the T1 sample, organic material filled several of these bubbles, which act as a protective location but also serve to retain biological weathering agents. (Fig. 87.4 upper right). In T3, an 80 μm bubble was completely filled with a flaked material, probably now clay (Fig. 87.4 lower left). This may have been an unmelted inclusion in the glass, perhaps of the sodic flux added to the raw material. It weathered into plates concentric to the circumference of the bubble.

Fig. 87.4 Surface weathering on tesserae: parallel cracking in grooves (**T1**); vesicle filled with organic material (**T2**); vesicle filled with clay, surrounded by mosaic fractures (**T3**); mosaic fracture patterns and shallow craters (**T4**)

surface stress, but from various causes. The smallest cracks define small ($<20\ \mu\text{m}$) polygonal flakes, best seen on T3 (Fig. 87.4 lower left) and T4, but not observed on T1 and T2 (concordant with the visibly better condition of T1 and T2). The cracks and polygonal flakes are shallow surface features. Likely, polygonal cracking is a result of glass corrosion in either a subsoil or subaerial environment, described by Römich (1999). Atmospheric or soil acids are capable of leaching the alkaline elements of the sodic components. While SEM-EDS identified the presence of alkaline elements on the glass surface (Fig. 87.5), specific element loss (compared to the interior of the specimen) awaits cross-sectional microanalysis.

Fine polygonal cracks were in some instances contained within angular surface blocks, defined by larger cracks up to $20\ \mu\text{m}$ wide. On the T4 specimen, these larger cracks cut through shallow craters or pits (Fig. 87.4 lower left and lower right). The crack-defined areas, $\sim 100\text{--}500\ \mu\text{m}$ in diameter, resemble macroscopic exfoliation seen on rock surfaces, and may be caused by temperature stress, salt crystal growth, hydration or dehydration of glass (which may originally contain up to 20 % water, Römich 1999), or

The third type of cracking, linear cracks (Fig. 87.4 upper left), appeared parallel to striations. We believe the striations, hundreds of μm long and $5\text{--}10\ \mu\text{m}$ wide, to be manufacturing artifacts, possibly from irregular cooling or mixing of raw material, from cutting the glass into tesserae, or from polishing the glass. Striations were not apparent on all surfaces, and linear cracking not apparent on all striations. The linear cracks, $\sim 0.5\ \mu\text{m}$ wide, formed in the “troughs” of the striations. Linear cracks may be the result of cooling and shrinking during manufacture, from post-manufacture exposure to temperature extremes, glass hydration/dehydration, clay expansion, or salt crystal growth below the plates (given the presence of Cl, Na, and K identified within the glass matrix, Fig. 87.5). The linear cracks are likewise large enough to allow entry for weathering agents, extending the deterioration feedback. Thin overgrowths or coatings were identified on flat surfaces, particularly on striated surfaces. These overgrowths are probably secondary deposits of silica.

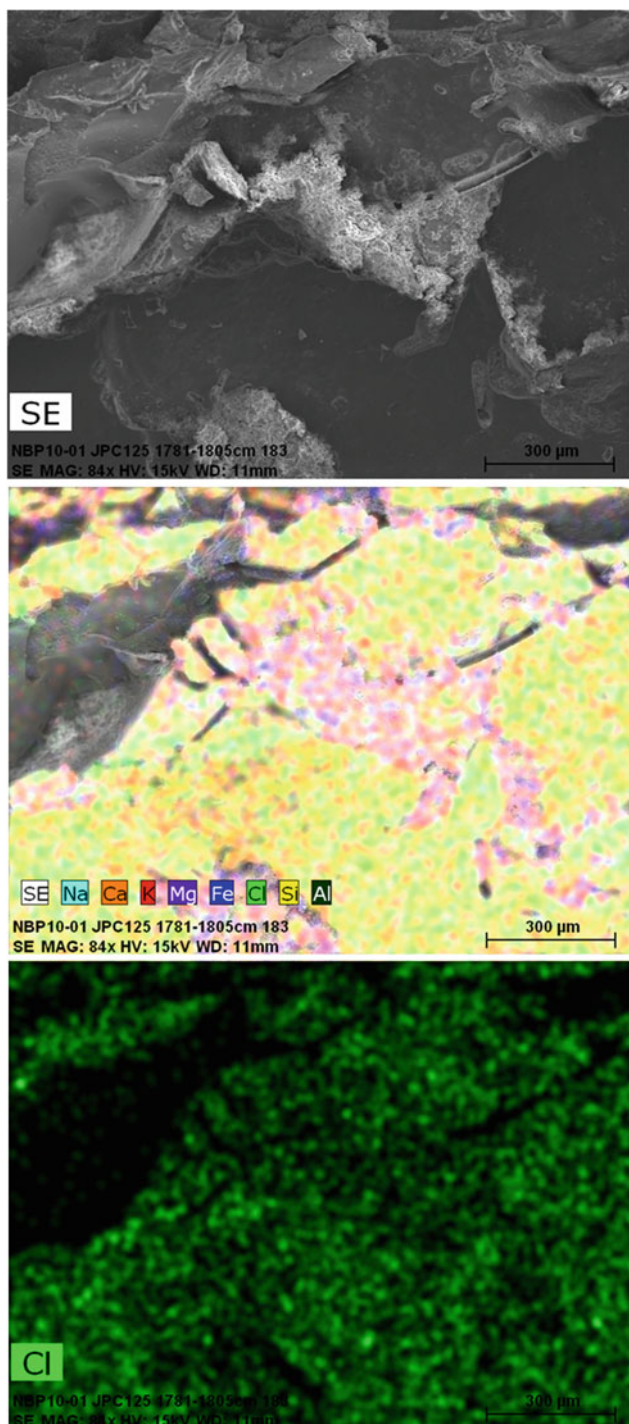
The chemical composition of the tesserae was variable. The major components of silica, calcium, and soda (Na) were apparent. Minor peaks of iron and chlorine were detected in some locations, due to impurities, colorants (Croveri et al. 2010; Fleming 1997), or possible use of evaporite salts for flux. Most components were homogenous throughout with the exception of T2, which gave indications of element segregation (Fig. 87.5).

Fig. 87.5 Qualitative element analysis of T2 with EDS. Identical areas imaged: secondary emission (*top*), mixed element mapping (*center*), chlorine content (*bottom*). Scale bar 300 µm in each
