# DAM REMOVAL IN THE USA: EFFECTS ON RIVER WATER QUALITY

*Michael A. Kruge*

### ABSTRACT

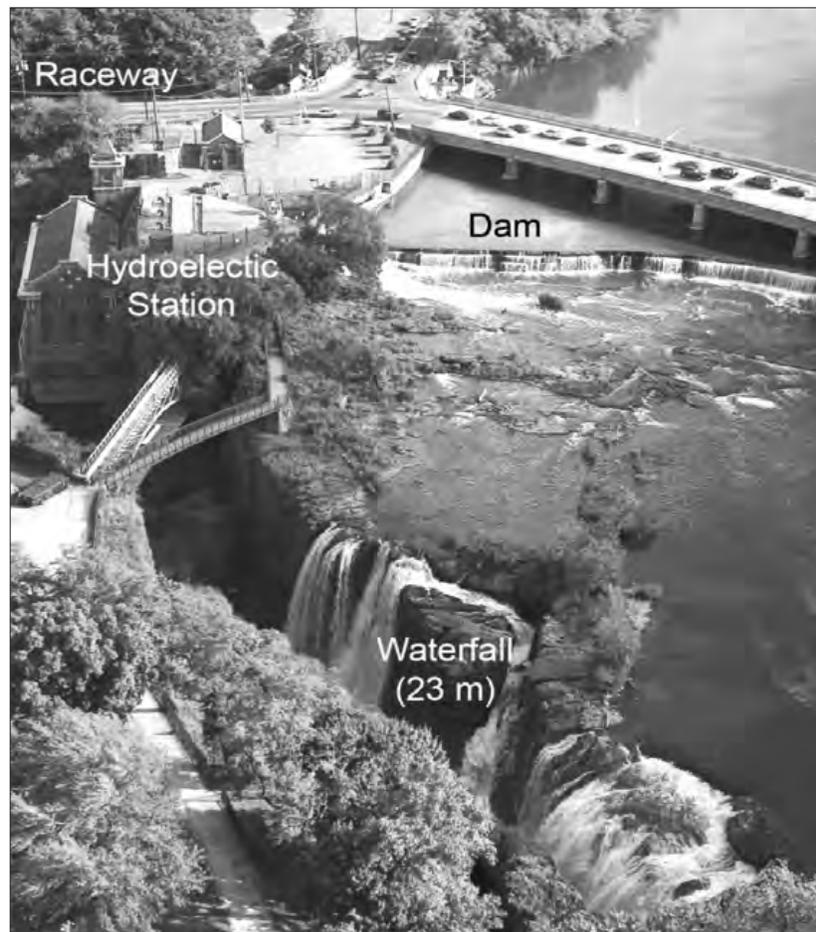
**Figure 1. Aerial view of the Great Falls of the Passaic River (Paterson, New Jersey) in March, 2004. See Table 1 for location of this site as well as the others illustrated in the figures. Photo: Mike Peters, Montclair State University. Used with permission.**

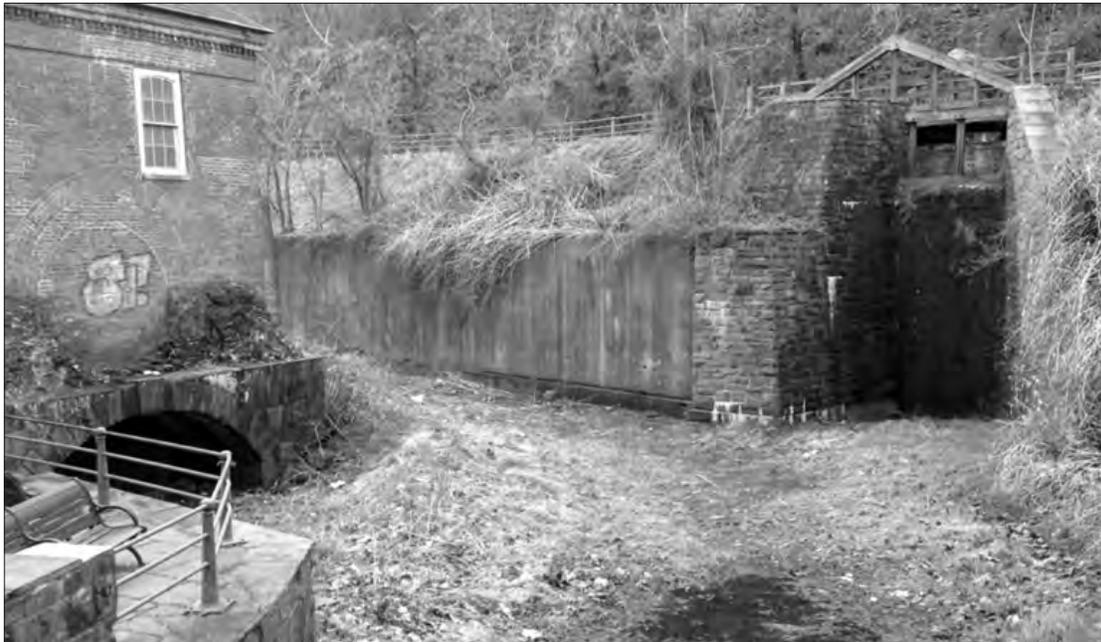
**Figure 2. Remnants of the raceway system in Paterson (April, 2015). Note the sluiceway at the right which served to admit water from the upper canal at the top of the image. The circular pattern in the bricks on the wall of the industrial building on the left marks the former entrance of the rotating driveshaft. Photo: M. Kruge.**

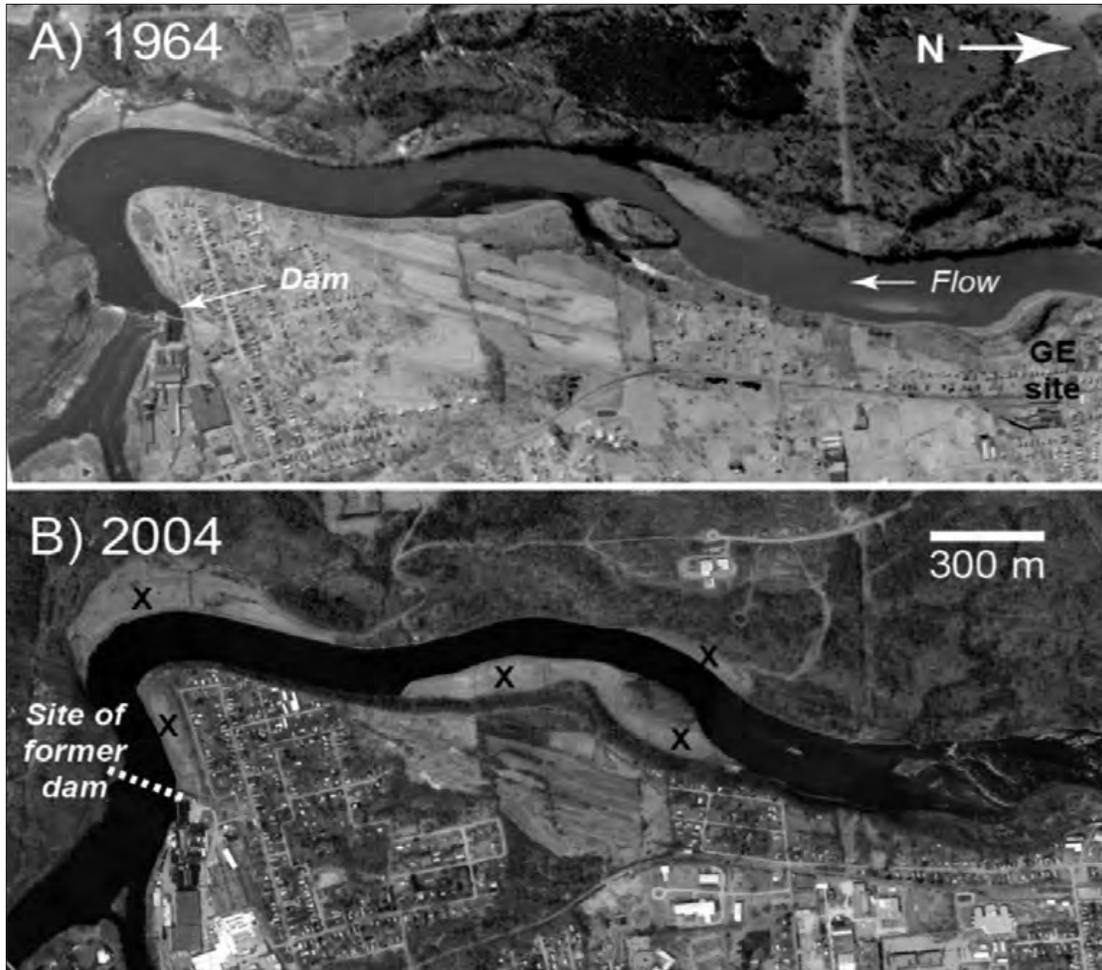
**Figure 3.** Aerial views of the Hudson River at Fort Edward (New York). A) Image from 1964 while the dam (at left) was in place, downstream from the General Electric capacitor factory (at right). Map imagery: United States Geological Survey. B) The same area in 2004 showing the site of the former dam. Light colored zones marked with black X's are the PCB remnant deposit sites exposed by the draining of the reservoir. Map imagery: Google Earth, New York GIS.

The contamination concerns provoked by the removal of the Fort Edward dam are twofold. Comparing Figures 3A and 3B, it is evident that draining the reservoir exposed large areas of sediment, namely the light-colored patches marked by X's in Figure 3B (USEPA, 2012). These remnant deposits have high

levels of PCB contamination, but remain a fairly localized hazard. However, PCB-contaminated sediments in the riverbed were also able to migrate downstream after the removal of the barrier in 1973, especially during intense storm events (Schneider *et al.*, 2007). In its lower reaches, the Hudson River is an estuary, such that sediments can migrate back upstream with the flood tide. After decades of PCB residence in this complex fluvial/estuarine regime, the net result is that the river is contaminated all the way down to its mouth in New York City harbor (USEPA, 2012).

The USEPA initially placed the Hudson River site on the Superfund list in 1984 (Figure 4), with the goal of capping the remnant deposits (Figure 3B) with

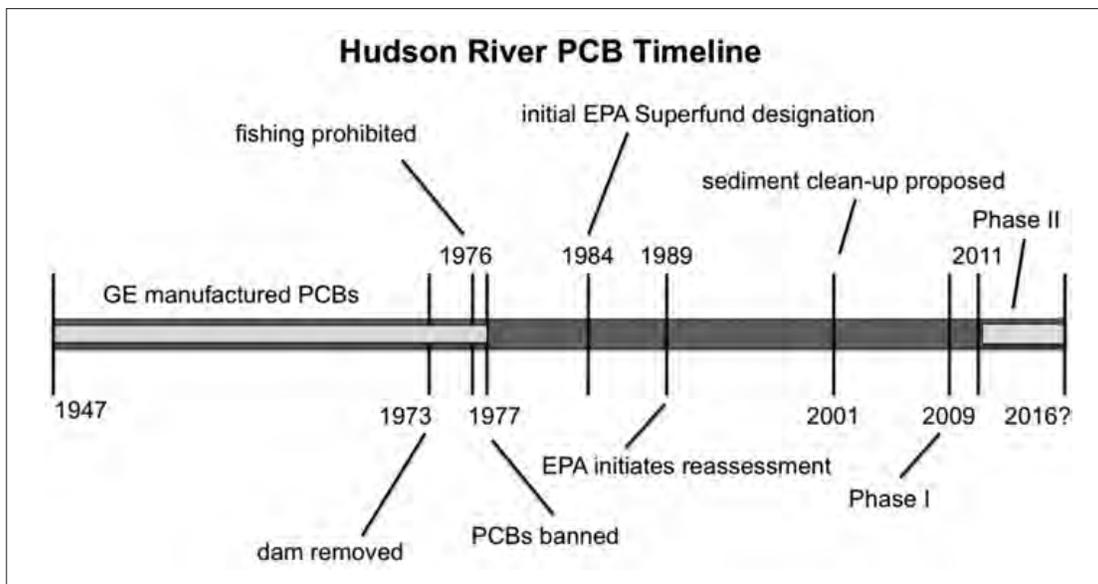
**Figure 4. Timeline showing the key dates in the history of Hudson River polychlorinated biphenyl (PCB) contamination and cleanup. Data source: USEPA (2012).**

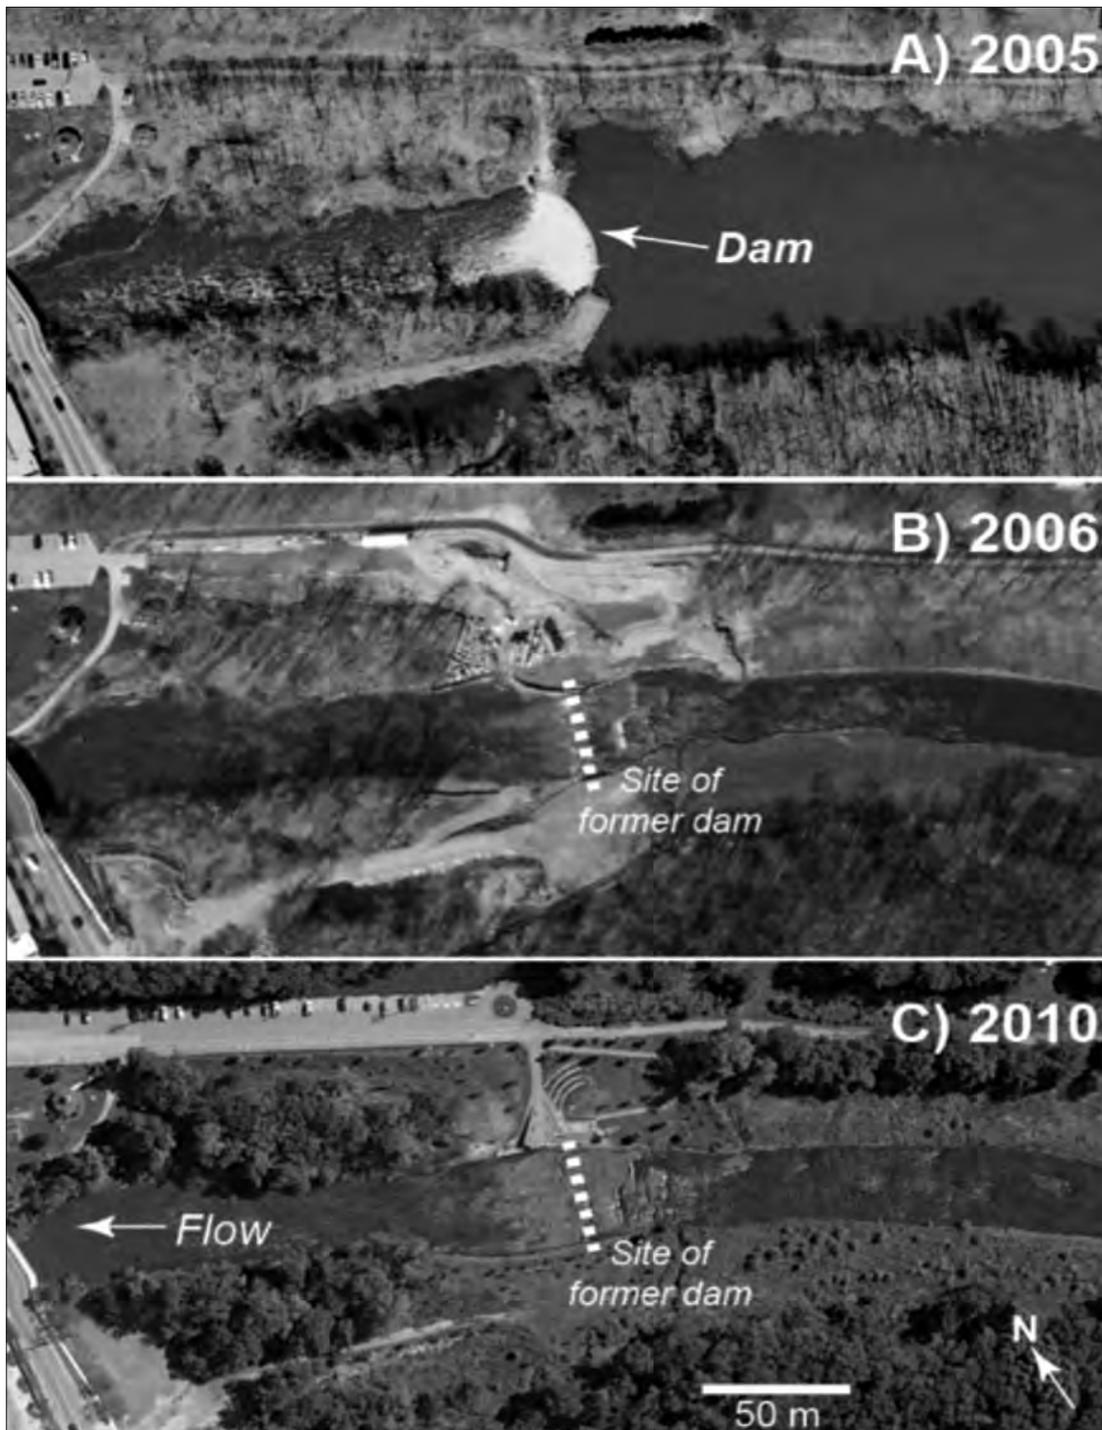
**Figure 5.** Sequence of aerial images of the Munroe Falls dam site, Cuyahoga River (Ohio). Map imagery: Google Earth, State of Ohio/OSIP. A) View in the year 2005 prior to the removal of the dam. B) View in 2006 shortly after dam removal. C) View in 2010 showing completed landscaping and public park.

River channel profiling revealed that erosive down-cutting was primarily localized in the deepest parts of the former reservoir, reaching the pre-dam river bed surface only one month after dam removal, while the reservoir sediments on the margins remained largely in place. Remobilized sediments were transferred down the river below the site of the former dam, significantly altering river bed morphology and sedimentology (Rumschlag and Peck, 2007). Similar observations were made in a decade-long geomorphological study of the effects of the Stronach dam removal on the Pine River in Michigan (Burroughs *et al.*, 2009). The reestablished Cuyahoga River channel occupies about 30% of the width of the reservoir above the dam site (Figures 5A, B); the reclaimed land was repurposed as a public park (Figure 5C).

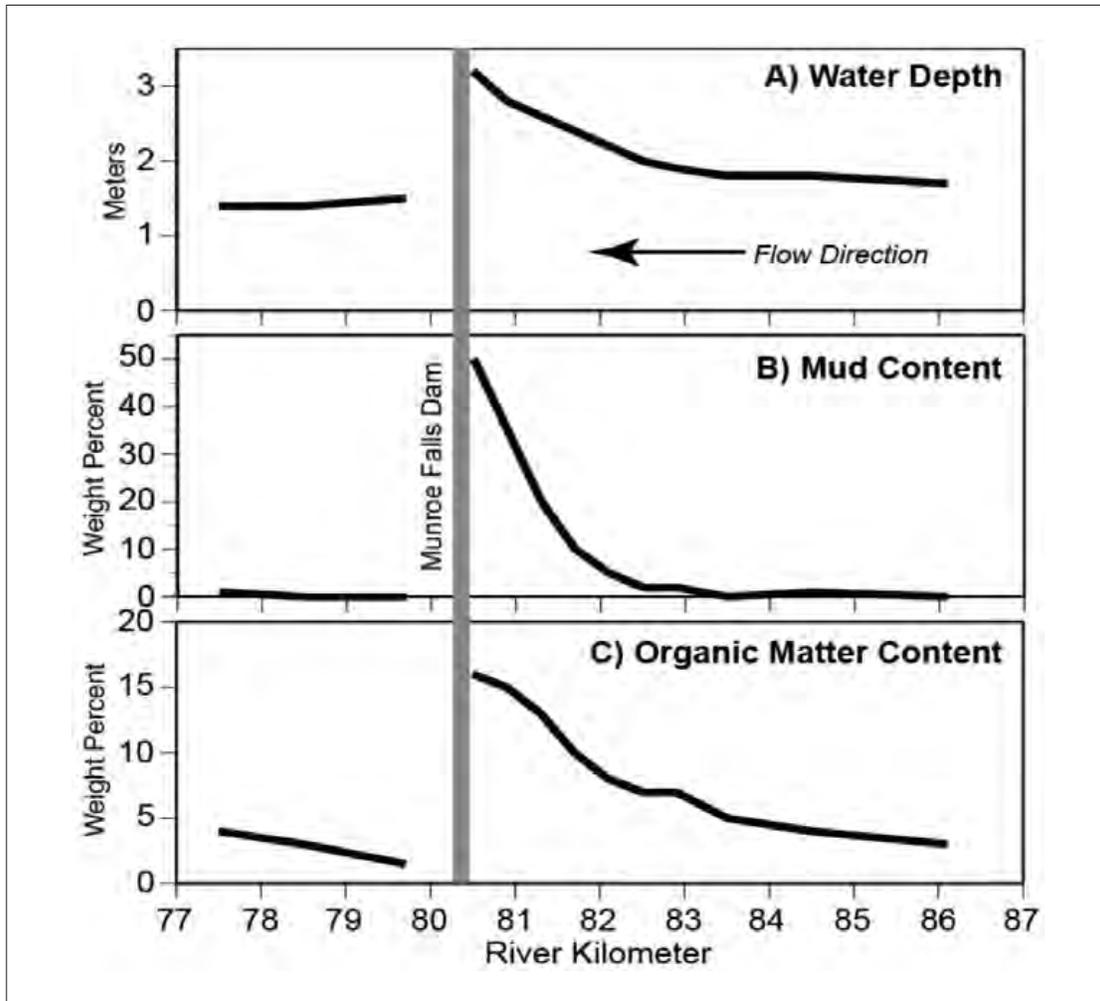
**Figure 6. Conditions between river kilometers 77 and 87 prior to the removal of the Munroe Falls dam, Cuyahoga River (Ohio). Data from Peck *et al.* (2007). A) Water depth in the main channel above and below the dam. B) Proportion of mud in the sediment (grain size < 63  $\mu\text{m}$ , normalized on an organic matter-free basis). C) Proportion of organic matter in the sediment, as measured by the loss-on-ignition method.**

The Munroe Falls reservoir illustrated the classic effects of decades-long impoundment (Peck *et al.*, 2007). Concomitant with the increased water depth behind the dam (Figure 6A) and reduced stream flow velocity, muddy deposits extended a kilometer upstream (Figure 6B). In addition, the reservoir muds were highly enriched in organic matter, due to the relatively stagnant water conditions (Figure 6C). As mentioned previously (Section 3), this sequestered carbon is subject to alteration after the lake has been drained, potentially releasing greenhouse gases. Radiometrically-dated core samples taken in reservoir prior to dam removal provided a detailed record of the environmental history at the site. The sedimentology and trace metal contents indicated that episodic flood events had mobilized industrial contaminants from upstream sites, but resulted in levels that were unlikely to be significantly bioavailable (Peck *et al.*, 2007).

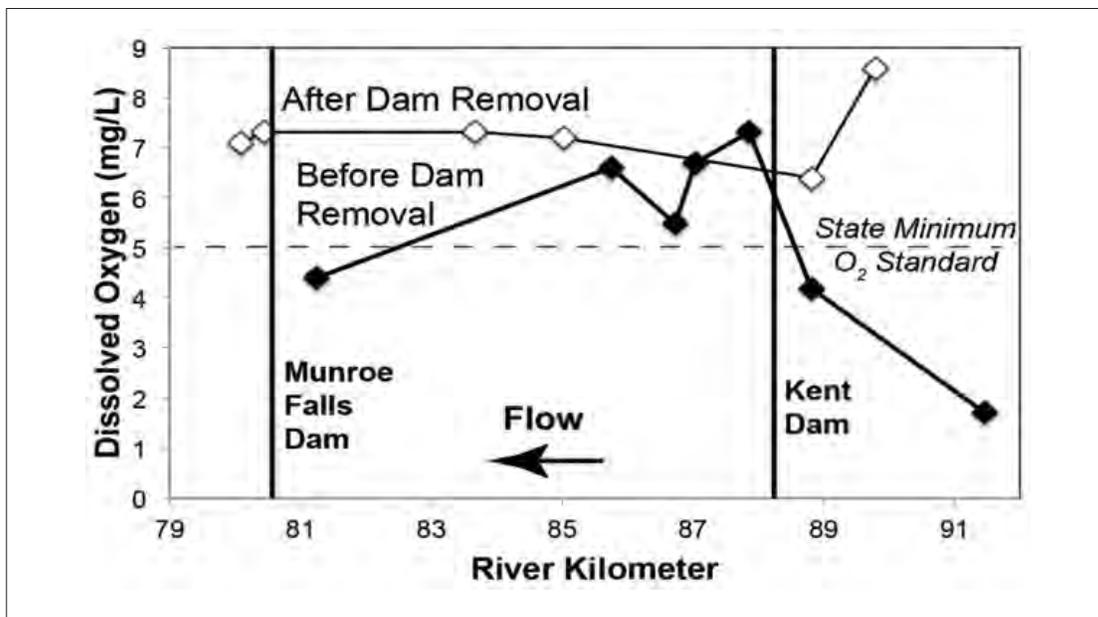
**Figure 7.** Mean summer (month of August) dissolved oxygen concentrations in Cuyahoga River water before and after the removal of the Munroe Falls and Kent dams. Data from Tuckerman and Zawiski (2007).

The stagnant water conditions behind the Munroe Falls dam and the companion Kent dam 8 km upstream led to seasonal hypoxia in the reservoirs, impacting aquatic life. The 19th century Kent dam was one of the oldest arched masonry dams in the United State. The desire for a free-flowing river was at odds with the need for the preservation of this historic structure. After a series of formal community meetings, governmental agencies devised a compromise plan to divert the principal streamflow around the arched dam, which was left in place as an artificial waterfall (Tuckerman and Zawiski, 2007). With the removal of the Munroe Falls dam and the bypass of the Kent dam, summer dissolved oxygen levels improved markedly, exceeding the regulatory standard (Figure 7).

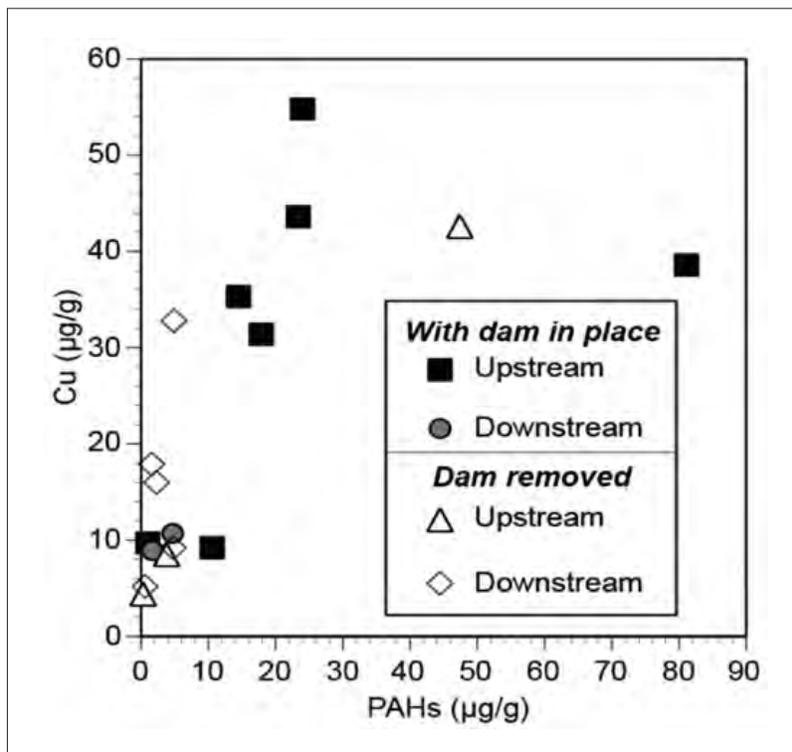
**Figure 8. Concentrations of contaminants in the sediments of Manatawny Creek (Pottstown, Pennsylvania) upstream and downstream of the dam site, before and after dam removal. Copper and total polycyclic aromatic hydrocarbons (PAHs) are shown as examples of inorganic and organic contaminants, respectively. Data from Ashley *et al.* (2006).**

Even though contaminants may be present in the river system, the removal of a small dam may have little net impact on them. Sediments above and below the 2.5 m high run-of-river Manatawny Creek dam were analyzed for polychlorinated biphenyls (PCBs), polycyclic aromatic hydrocarbons (PAHs), and trace metals both before and after the dam was removed. Manatawny Creek is a fourth-order stream flowing into the Schuylkill River in southeastern Pennsylvania. While the results indicated that concentrations of some contaminants were elevated, the dam removal made little difference (Figure 8). The dam was demolished in two stages to reduce the likelihood of sudden impact, but concerns were lessened upon noting that its reservoir did not contain much of the fine-grained sediment likely to trap contaminants (Ashley *et al.*, 2006). Similar results were reported in a study of the removal of a 1.5 m high run-of-river dam in an urbanized reach of the Pawtuxet River (Rhode Island), with little change observed in PAH and PCB concentrations (Cantwell *et al.*, 2014).

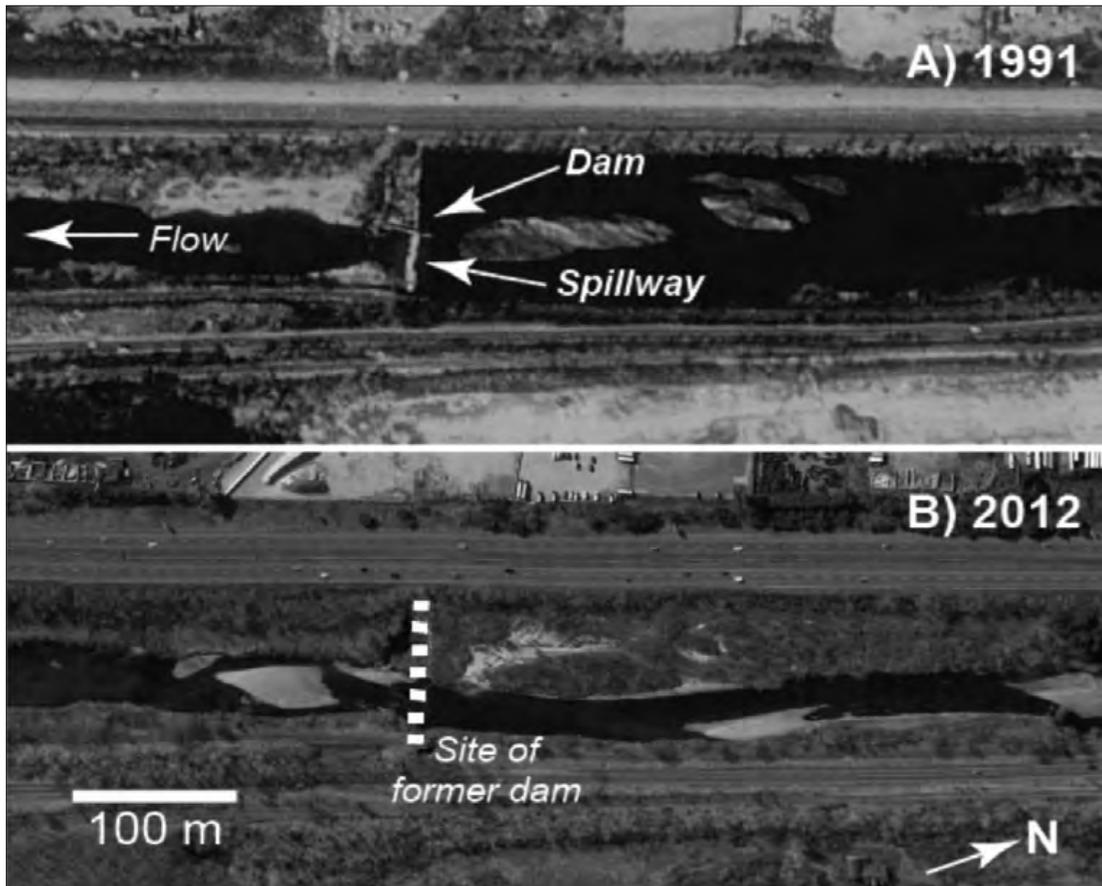
Figure 9. Sequence of aerial images of the Anaconda dam site, Naugatuck River (Waterbury, Connecticut). Map imagery: Google Earth, U.S. Geological Survey. A) View in the year 1991, with dam in place. Note the wide spillway along the eastern half of the dam. B) View in 2012, after removal of dam.

The Naugatuck River (Connecticut), a major tributary of the estuarine Housatonic River, was once known for its abundance of anadromous fish, particularly *Alosa spp.* With the advent of the Industrial Revolution, fish migration was impeded by the dams built to serve the new mills. These water-powered facilities evolved into heavy industrial complexes by the early 20th century, giving the Naugatuck its reputation as “Connecticut’s dirtiest river”. By the century’s end, the condition of the river was beginning to improve as a result of environmental regulations, closure of the factories due to global economic shifts, and public concern. Dams were removed or by-passed with hopes for ameliorating fish habitat (Howard, 1999). As one of eight dams involved in the ongoing Naugatuck River restoration efforts, the Anaconda dam (Figure 9A) was removed in 1999.

Standing 3.4 m high and 100 m long, it was deteriorating and hazardous. After extensive sediment analysis, the broad spillway on its east side was to be opened and impounded sediments removed to prevent their remobilization. Before these plans could be implemented, a strong storm breached the dam at the spillway. It had to be dismantled quickly, under an emergency decree, to prevent erosive damage to a municipal sewer main. The river soon reestablished itself, scouring a slightly sinuous channel down to the pre-dam riverbed on the east side of the former reservoir (Figure 9B), nearing an equilibrium state in only four years. Much of the reservoir sediment on the west side remains in place as a dewatered, vegetated floodplain, naturally armored over time with coarse sediment. The urgent spillway demolition precluded completion of the planned sediment testing. PAHs were detected, but in relatively low concentrations, likely due to the predominance of coarse-grained deposits. In the years since dam removal, fish populations have increased and recreational angling is now possible (Wildman and MacBroom, 2005).

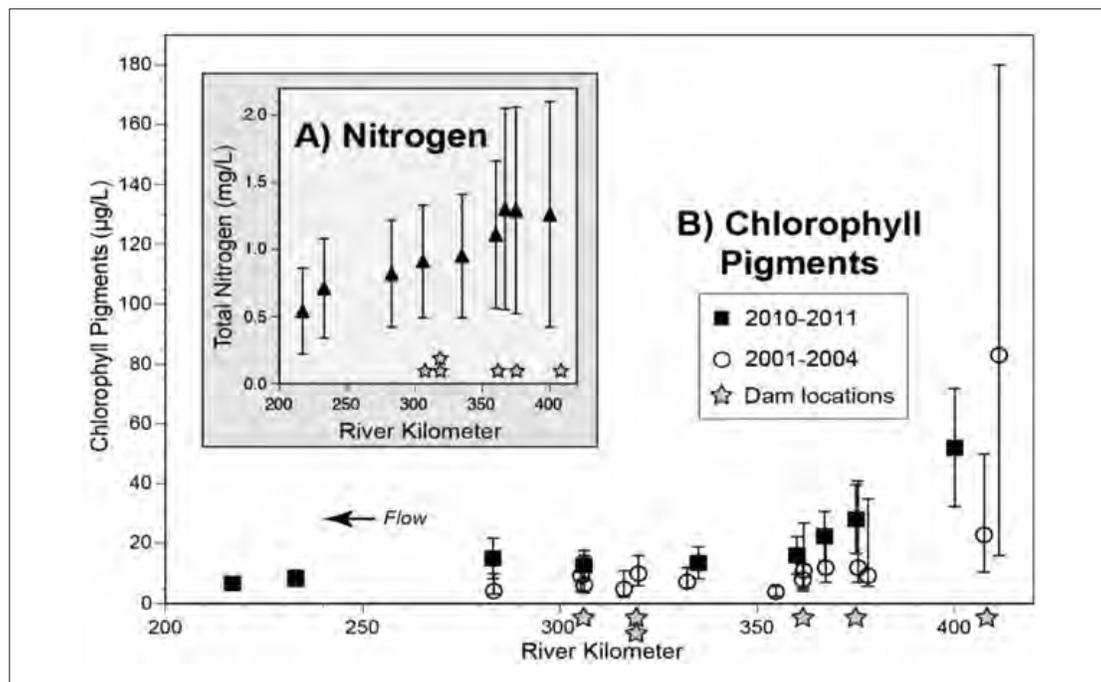
**Figure 10. Water quality in the Klamath River (Oregon and California) between river kilometers 200 and 420. Stars mark dam locations: Link River (upstream), Keno, J.C. Boyle, Copco Nos. 1 & 2, and Iron Gate (downstream). A) Total nitrogen concentrations in 2010-2011 (data from Oliver *et al.* (2014)). B) Concentrations of chlorophyll pigments measured from 2001 to 2004 (data from Kann and Asarian (2006)) and in 2010-2011 (data from Oliver *et al.* (2014)).**

In the predominantly rural upper Klamath River valley, another primary concern is poor water quality (Sullivan *et al.*, 2013). This stretch of the river suffers from low dissolved oxygen and high ammonia levels, as well as seasonally elevated pH in the relatively stagnant waters of the reservoirs. The total nitrogen concentrations rise upstream, above river kilometer 350 (Figure 10A). A similar trend is seen for chlorophyll pigment levels (Figure 10B), which provide a proxy indicator for the amount of algal biomass in the water. Excess nutrients (nitrogen and phosphorus) from both point and non-point sources stimulate noxious summer blooms of cyanobacteria and diatoms in the lentic impounded waters (Kann and Asarian, 2006; Oliver *et al.*, 2014; Sullivan *et al.*, 2013). For the uppermost stretch (above river kilometer 375) dam removal is not being contemplated. Instead, possible remedies could include more stringent controls on wastewater treatment plant effluents, diversion of the uppermost stream through a wetland for passive filtration, and periodic physical removal of suspended particulate matter in the water column (Sullivan *et al.*, 2013). Upper Klamath Lake (constituting the headwaters, just above river kilometer 400) is natural, but its level is regulated and it is itself subject to algal blooms, further complicating the water quality problem (Kann and Asarian, 2006; Oliver *et al.*, 2014).

The four dams between river kilometers 300 and 370 (Iron Gate, Copco Nos. 1 & 2, and J. C. Boyle) have been evaluated for removal. The Iron Gate and Copco No. 1 reservoirs are the largest and contain predominantly muddy sediment. If this fine-grained material is released, the resulting turbidity could impair downstream habitat. The sediment was shown to have only insignificant levels of industrial contaminants, thus the concern is simply the large volume of impounded silt and clay (GEC, 2006; Stillwater, 2008). A gradual release would likely mitigate the problem, for example, by demolishing the smaller J.C. Boyle and Copco No. 2 dams first, then slowly draining the larger Iron Gate and Copco No. 1 reservoirs

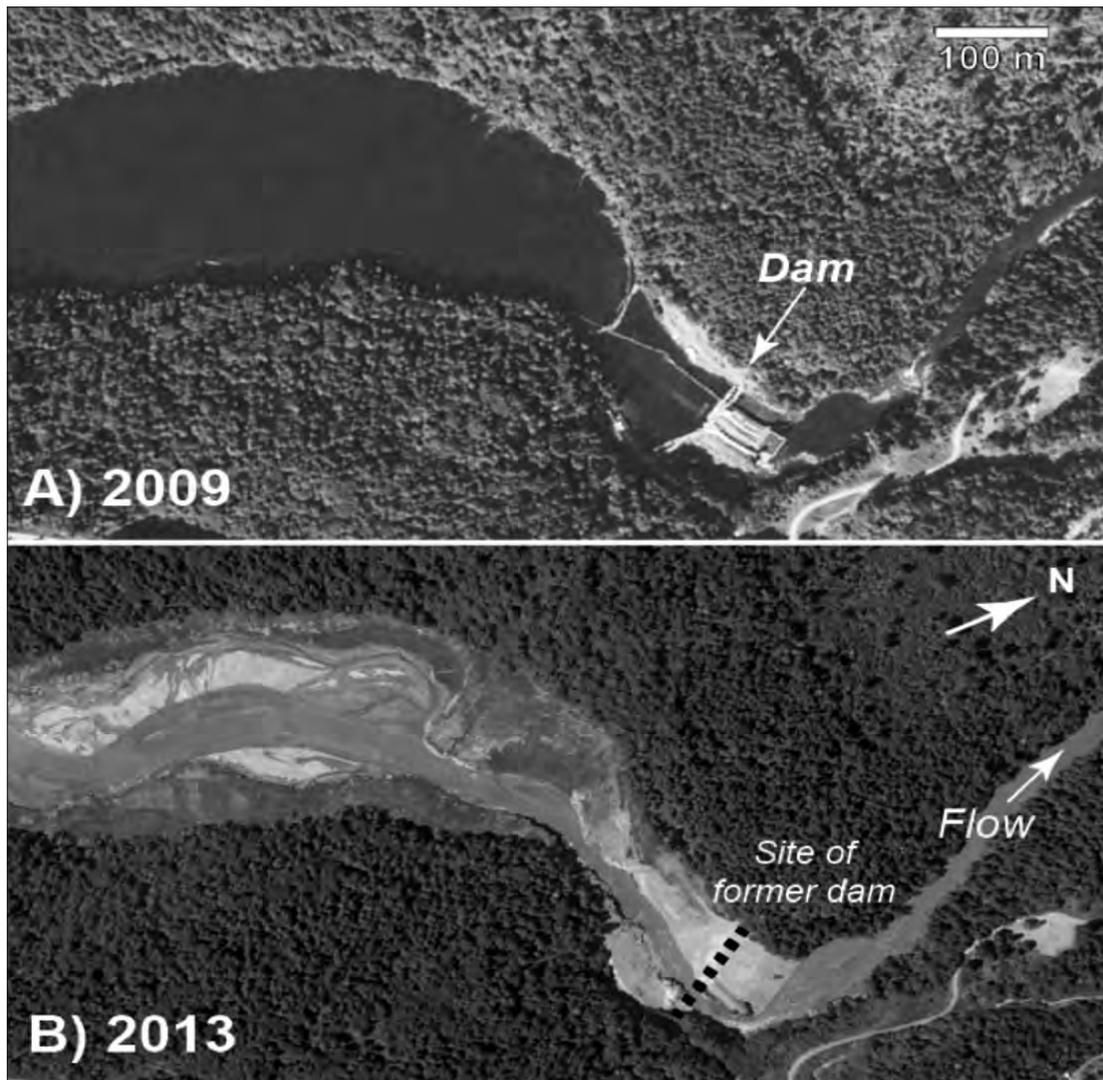
**Figure 11.** Sequence of aerial images of the Elwha dam site, Elwha River (Washington state). Map imagery: Google Earth, U.S. Department of Agriculture Farm Service Agency. A) View in the year 2009, with dam in place. B) View in 2013, after removal of dam.

upstream from the river's mouth at the Juan de Fuca Strait, the concrete Elwha dam was 33 m high (Figure 11A). The taller, arcuate Glines Canyon dam stood at 64 m, constructed 14 km farther upstream in 1927. Privately built for electricity generation with a combined capacity of 28 MW, the dams offered little flood control or water supply benefit (Randle *et al.*, 2015; Warrick *et al.*, 2015). The dams lacked fish ladders and effectively blocked anadromous fish runs. The U.S. Congress approved the purchase and demolition of the dams in 1992, recognizing that most of the river's watershed (as well as the Glines Canyon dam itself) was located in Olympic National Park. Due to persistent controversy, the actual removal was delayed for another two decades (East *et al.*, 2015; Nijhuis, 2014; Randle *et al.*, 2015).

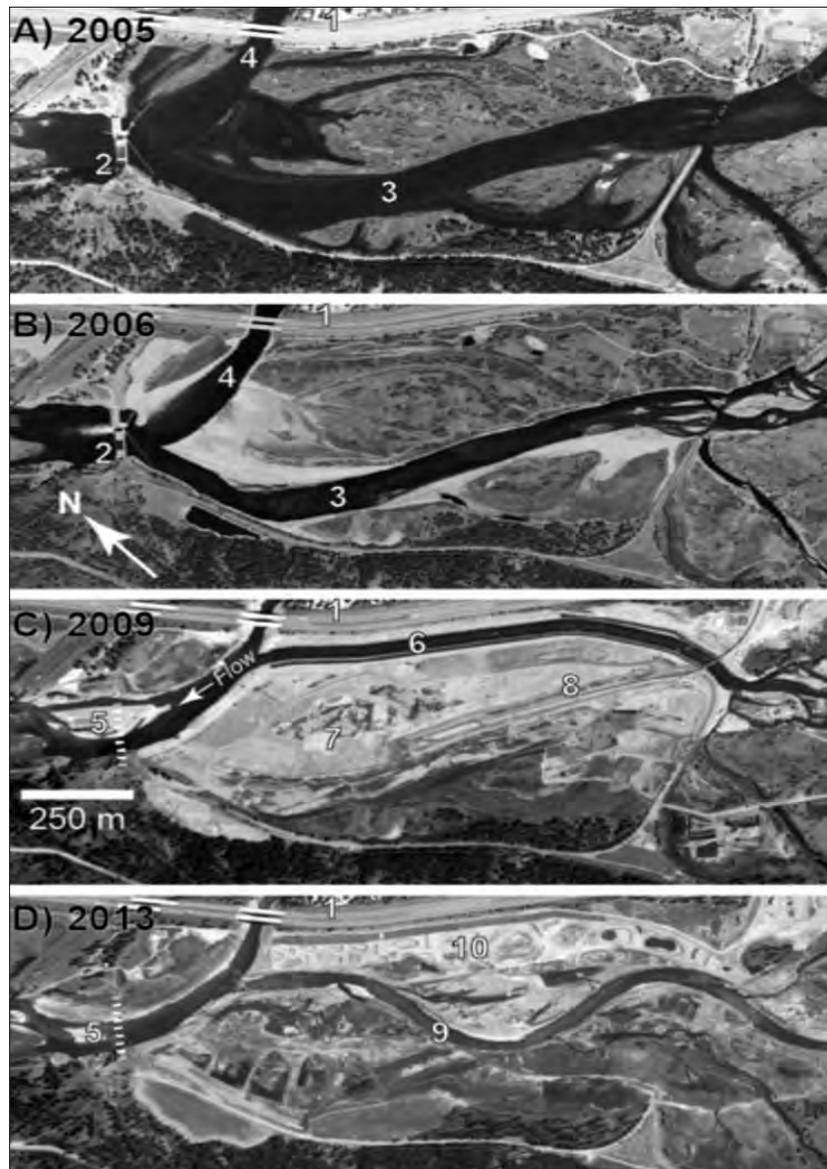
**Figure 12.** Sequence of aerial images of the Milltown dam site, confluence of the Clark Fork and Blackfoot Rivers (Montana). Map imagery: Google Earth, U.S. Department of Agriculture Farm Service Agency. A) View in the year 2005, with dam in place. B) In 2006 after the gradual draining of the reservoir. C) In 2009 after removal of dam and creation of a diversion channel to permit removal of contaminated reservoir sediment. D) In 2013 showing the restored, natural-appearing Clark River channel after completion of contaminated sediment removal. Key to indicated features: 1) municipality of Milltown, 2) Milltown dam, 3) reservoir behind dam (Clark Fork River), 4) reservoir behind dam (Blackfoot River), 5) former dam site, 6) temporary Clark River channel during floodplain sediment removal, 7) sediment removal activities in Clark River floodplain, 8) temporary railroad for sediment removal, 9) restored “natural” Clark River channel, 10) landscaping for the new state park.

As was done with the Elwha River dams (Section 4.5), the Milltown reservoir was first slowly drained (Figure 11B) prior to dam removal (Robbins, 2008; USEPA, 2011). While in the Montana case, the concern was contamination rather than turbidity, prudence and experience dictated a similarly patient approach. During reservoir draw-down, some increases in heavy metal concentrations were noted downstream (Plathe *et al.*, 2013). A temporary diversionary channel was established on the northern margin of the Clark River floodplain, permitting the dewatering of the contaminated sediments on the south side. A total of approximately 2 million m<sup>3</sup> of sediment were removed by railcar for supervised disposal offsite during 2007-2009 and the dam was demolished (Figure 11C). A sinuous, natural-appearing stream channel was reestablished through the remediated floodplain, the diversion closed, and a new state park was created on the reclaimed land (Figure 11D). Through the cooperation of federal and state governmental agencies, the local community, and the responsible parties, the project was brought to a successful conclusion (Clark-Fork-Coalition, 2015; DOJMT, 2015; USEPA, 2011; 2013)
