# Evaluating the Success and Monitoring the Usage of Wildlife Crossing Structures in Bedminster, NJ

Nicole Heather Bergen  
*Montclair State University*

A Master's Thesis Submitted to the Faculty of

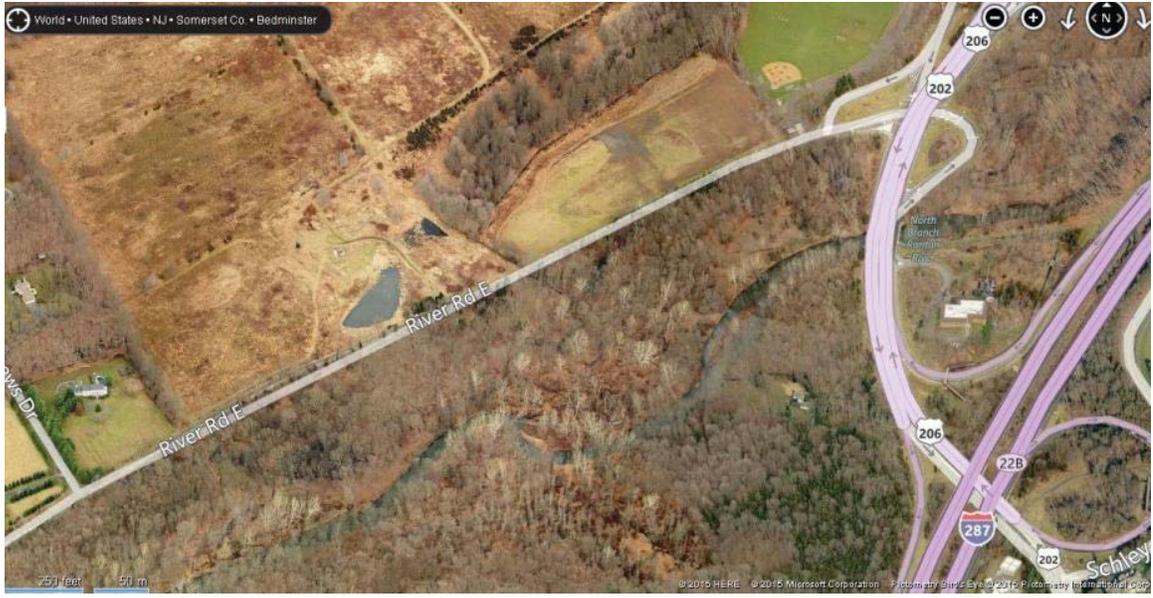
**Figure 1:** Map of River Road in Bedminster (Zarate et al, 2015).

On the north side of River Road, two ponds are located within 60 meters from River Road. This is where reptiles and amphibians migrate towards during mating season to forage and lay their eggs before returning back across the road to the wetland and wooded habitats (Brook 1997). There are five culverts located at the site running underneath River Road (Figure 1). The culverts were installed by the Township of Bedminster between 2014 and 2015 and are 61 cm wide by 61 cm high and are spread 160 meters apart from each other along River Road. The location of the culverts was determined using GPS coordinates from each culvert which were then put into ArcGIS.

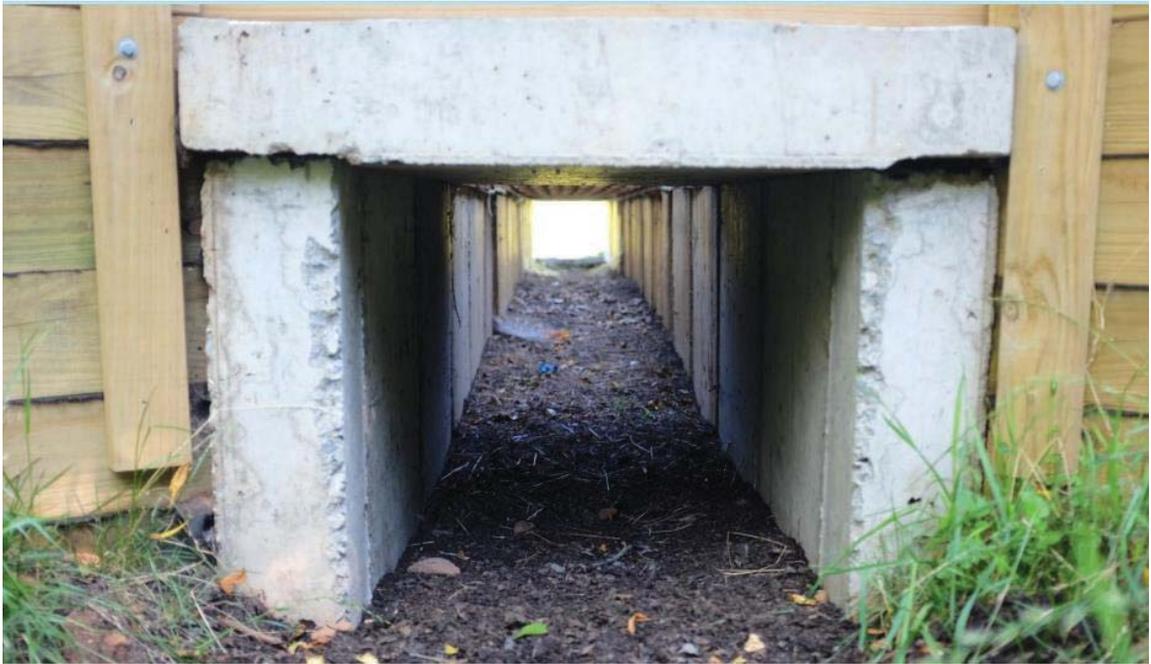
**Figure 2:** Culvert entrance. (61cm X 61cm). Pitfall trap (38cm (H) X 45cm (W) X 61cm (L)) installed at the culvert entrance. (Zarate et al. 2015).

The culverts were each made of three concrete trench boxes, each 3 meters in length, which extended across the width of the road. (Figure 2, Figure 3) The trench

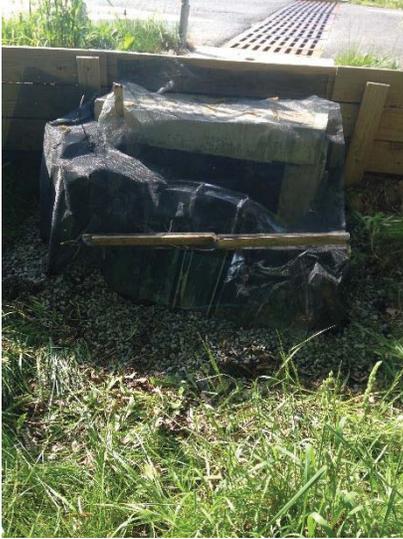
**Figure 3:** Enclosure set up on the wood side of the road. Closing off the wood side of the road allowed for the capture of organisms returning to the woods from the breeding ponds. Enclosure was created with screen and clear plastic to allow natural light and elements to enter.

The end of the culvert was where the pitfall trap contained screen fencing. The screen provided the most amount of natural light while prohibiting all species from entering the culvert from the opposite direction. This was to ensure that only the species crossing from one direction were going through the culvert. The screen was secured up against the culvert as well as into the ground to prevent any species from digging or squeezing around the fencing. The pitfall trap was documented and emptied at the end of every day during the study period (Figure 3).

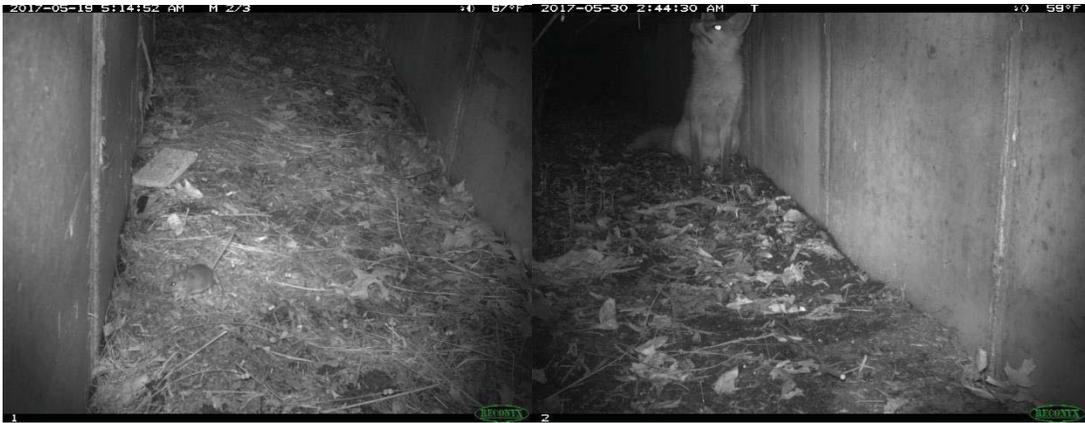
**Figure 4:** Motion triggered image of *Peromyscus maniculatus* (left) and timed interval image of *Vulpes vulpes* (right) in the culvert at early morning.

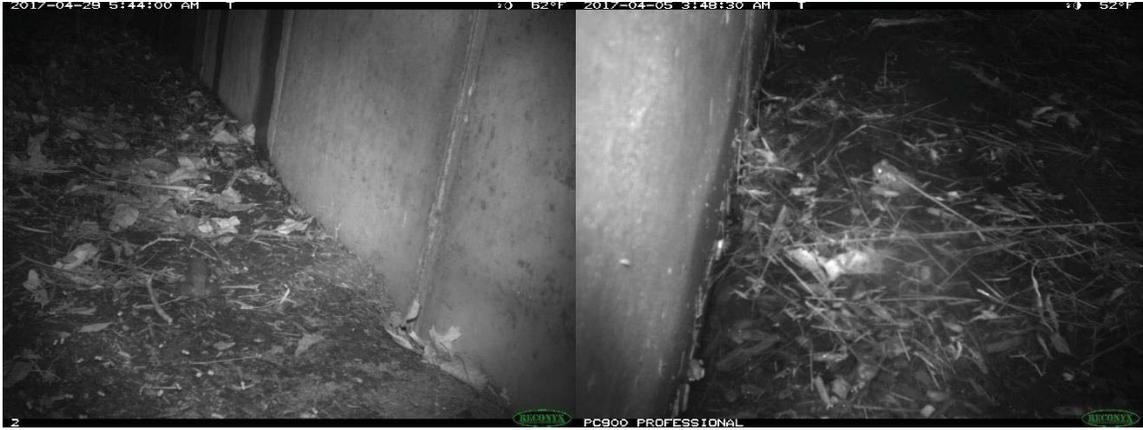
**Figure 5:** Timed interval image of *L. clamitans* (left) and *A. americanus* (right) in the culvert at early morning. The image on the right was taken when the culvert had flooded, and animals were still using it as a corridor.

Aside from technological difficulties, another challenge that occurred during this study was the excessive flooding in the culvert in the beginning of the study. The peak migration period for amphibians takes place at the end of February through the month of March, a time where excessive flooding occurs due to snow melt (Patrick et al. 2010). Migrating species in our study headed toward water sources, areas that were prone to flooding during this time. The culverts at River Road were located near water sources making flooding a common occurrence during the beginning of spring. At points throughout the beginning of the study (April 1, 2017- April 15, 2017) the culvert had up to 20 centimeters of water in it. The flooding not only caused standing water in the culvert, but it filled in the pitfall traps which were located below the surface, eliminating any organisms from being caught in the trap. Although amphibians could swim through the culvert when necessary, species such as deer mice and other small mammals were not able to cross through the culverts when they were flooded. This occurrence would make it difficult for the culvert to be a successful crossing method during this time period.

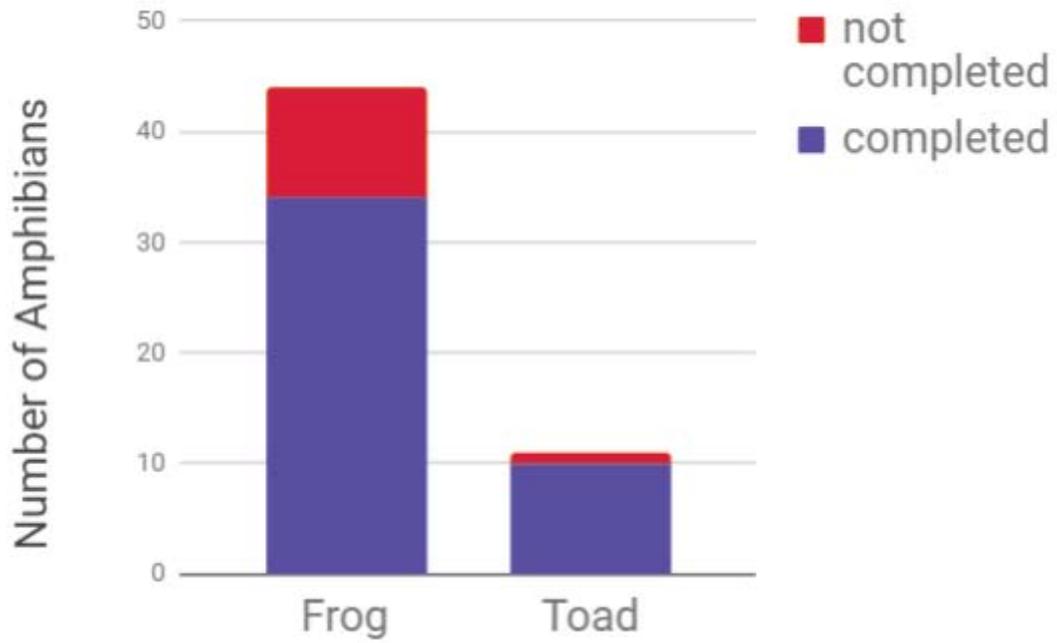
**Figure 6:** Culvert use by amphibians. In order for a migration to be considered complete an animal needed to go from one end of the culvert to the other.

Using the Chi-Square goodness of fit test, frogs were observed migrating through the culvert frequently, as well as American toads, deer mice and moles. The chi-square “goodness of fit” test observed a score of 18.21 and a p-value of 0.0004. Frogs were observed on camera more frequently using the culverts than American toads, deer mice and moles. Using a Chi-Square goodness of fit test, it was determined that there were differences amongst these species with a Chi-square score of 18.36 and a p-value of 0.0004. Of all the frogs that utilized the culverts, the most common animals observed using the culvert to get across the road were wood frogs and green frogs. Although frogs were observed migrating through the culverts more frequently using the cameras, the Chi-Square test examined the differences amongst the species studied and how often they were observed in the culvert. The successful crossings of these species suggested that the culverts were able to allow different animals’ from one side of the road to the other (Figure 6, 7 and 8).

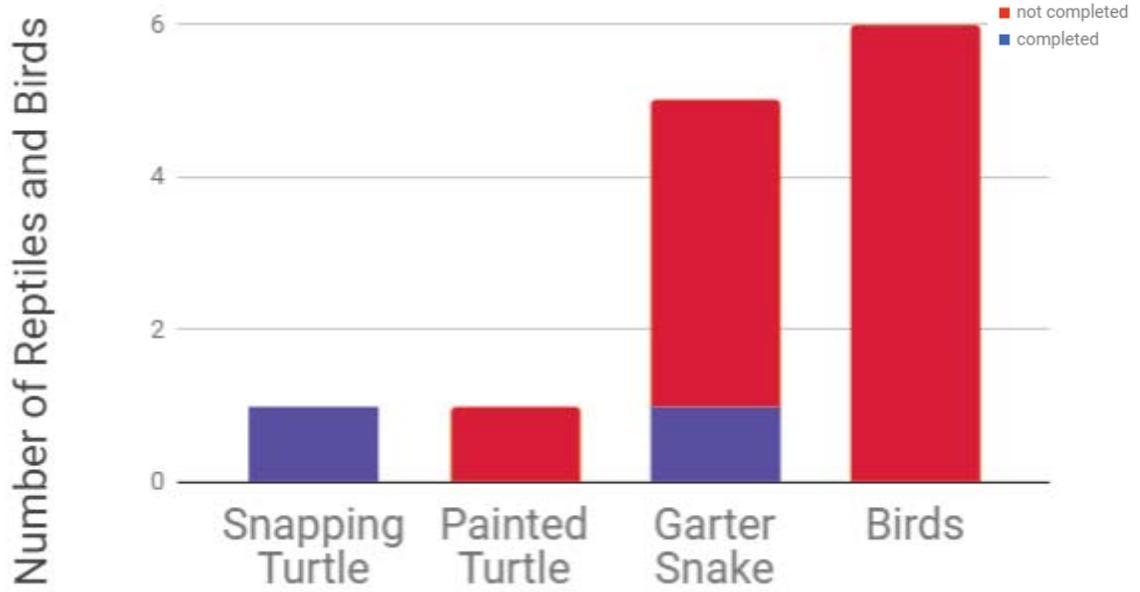
**Figure 7:** Culvert use by reptiles (including birds). In order for a migration to be considered complete an animal needed to go from one end of the culvert to the other.

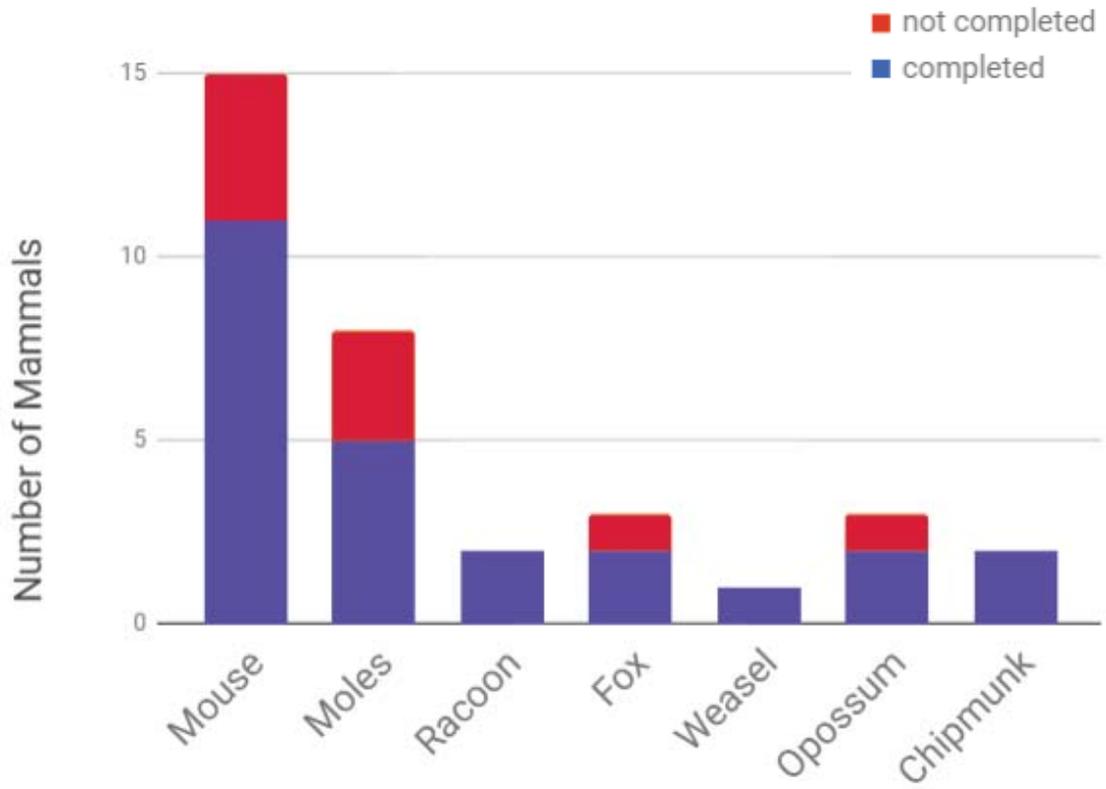
**Figure 8:** Culvert use by mammals. In order for a migration to be considered complete an organism needed to go from one end of the culvert to the other.

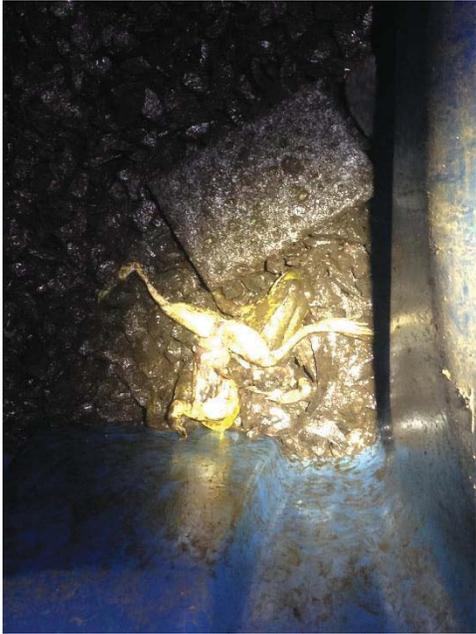
**Figure 9:** Four total amphibians were found dead in the pitfall trap during the study period. The cause of death was unknown.

There were a total of 55 amphibians that used the wildlife crossing structure as a migration pathway during the study period. Wood frogs and green frogs were difficult to differentiate between on camera so they were grouped together. A total of 37 amphibians migrated toward the breeding ponds, but 29 amphibians successfully completed the migration. When returning to the woods, 18 amphibians utilized the culvert and 15 of them successfully completed the migration back to the woods. Out of the 29 successful completions, 4 frogs were found dead throughout the study period in the pitfall traps. Their cause of death is unknown, but it is a possibility that their deaths were caused by a flying species that were able to avoid the camera.
